FLOODPLAIN RESPONSE AND RECOVERY: COMPARISON BETWEEN NATURAL AND ARTIFICIAL FLOODS

Goyder Institute for Water Research
Technical Report Series No. 13/4

Holland KL, Turnadge CJ, Nicol JM, Gehrig SL and Strawbridge AD. (2013) *Floodplain response and recovery: comparison between natural and artificial floods*, Goyder Institute for Water Research Technical Report Series No. 13/4, Adelaide, South Australia

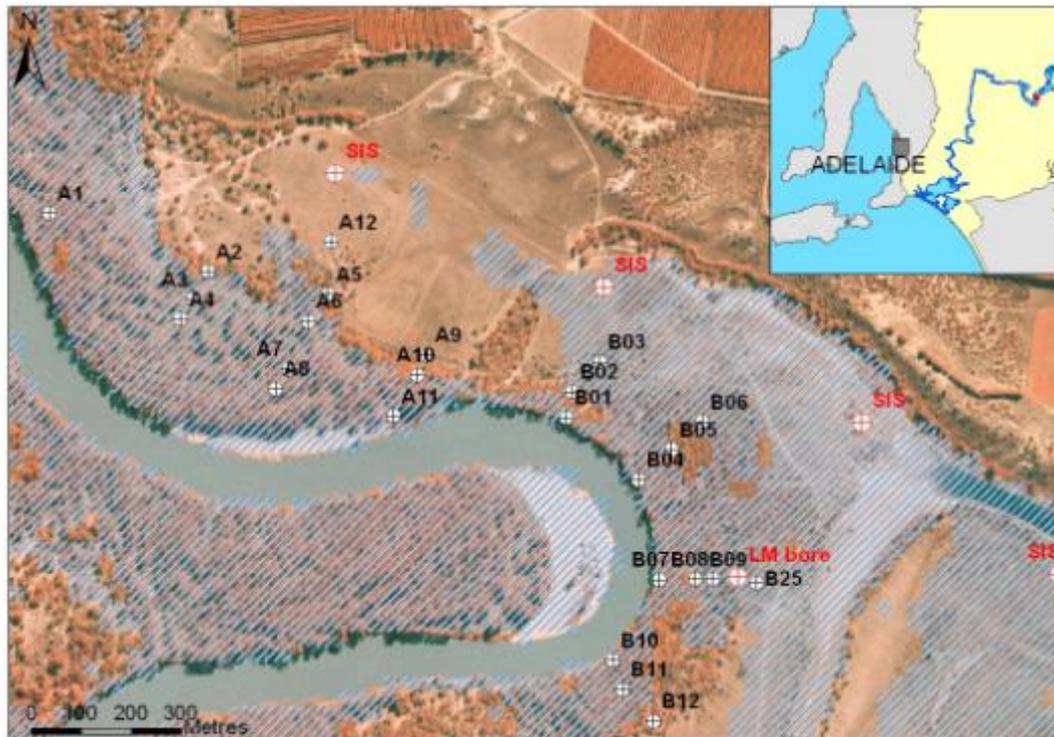
Figure 2 Location of piezometers at Site A and Site B at Bookpurnong. The blue hatching indicates the approximate extent of a 94 GL d⁻¹ flood (RiM FiM Overton *et al.* 2006). The inset map shows the location of the Bookpurnong floodplain in the South Australian Riverland.

conditions near the river (10-20 m from the river), in the middle of the riparian zone (70-110 m from the river) and at the distal edge of the riparian zone (130-190 m from the river) (Figure 2) were measured between December 2005 and December 2008 and between December 2010 and October 2011 (this report). Transect B2 was partially inundated by artificial watering in September 2006, before the flood runner creeks dried naturally within three to four months (Holland *et al.* 2009b). All transects were partially inundated by the natural flood in 2010/11.

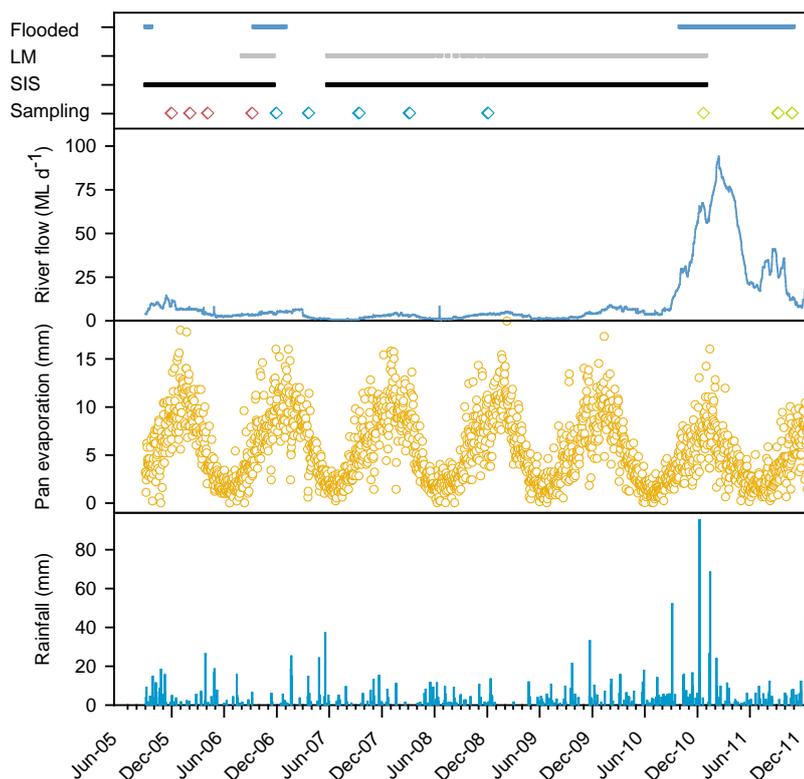
Figure 3 Bookpurnong project timeline. Timing of flooding, LM and SIS production bore operation, Bookpurnong sampling trips, river flow to South Australia (Station A4260200, DfW 2012), daily pan evaporation and rainfall at Loxton (Station 024024, SILO, 2012).

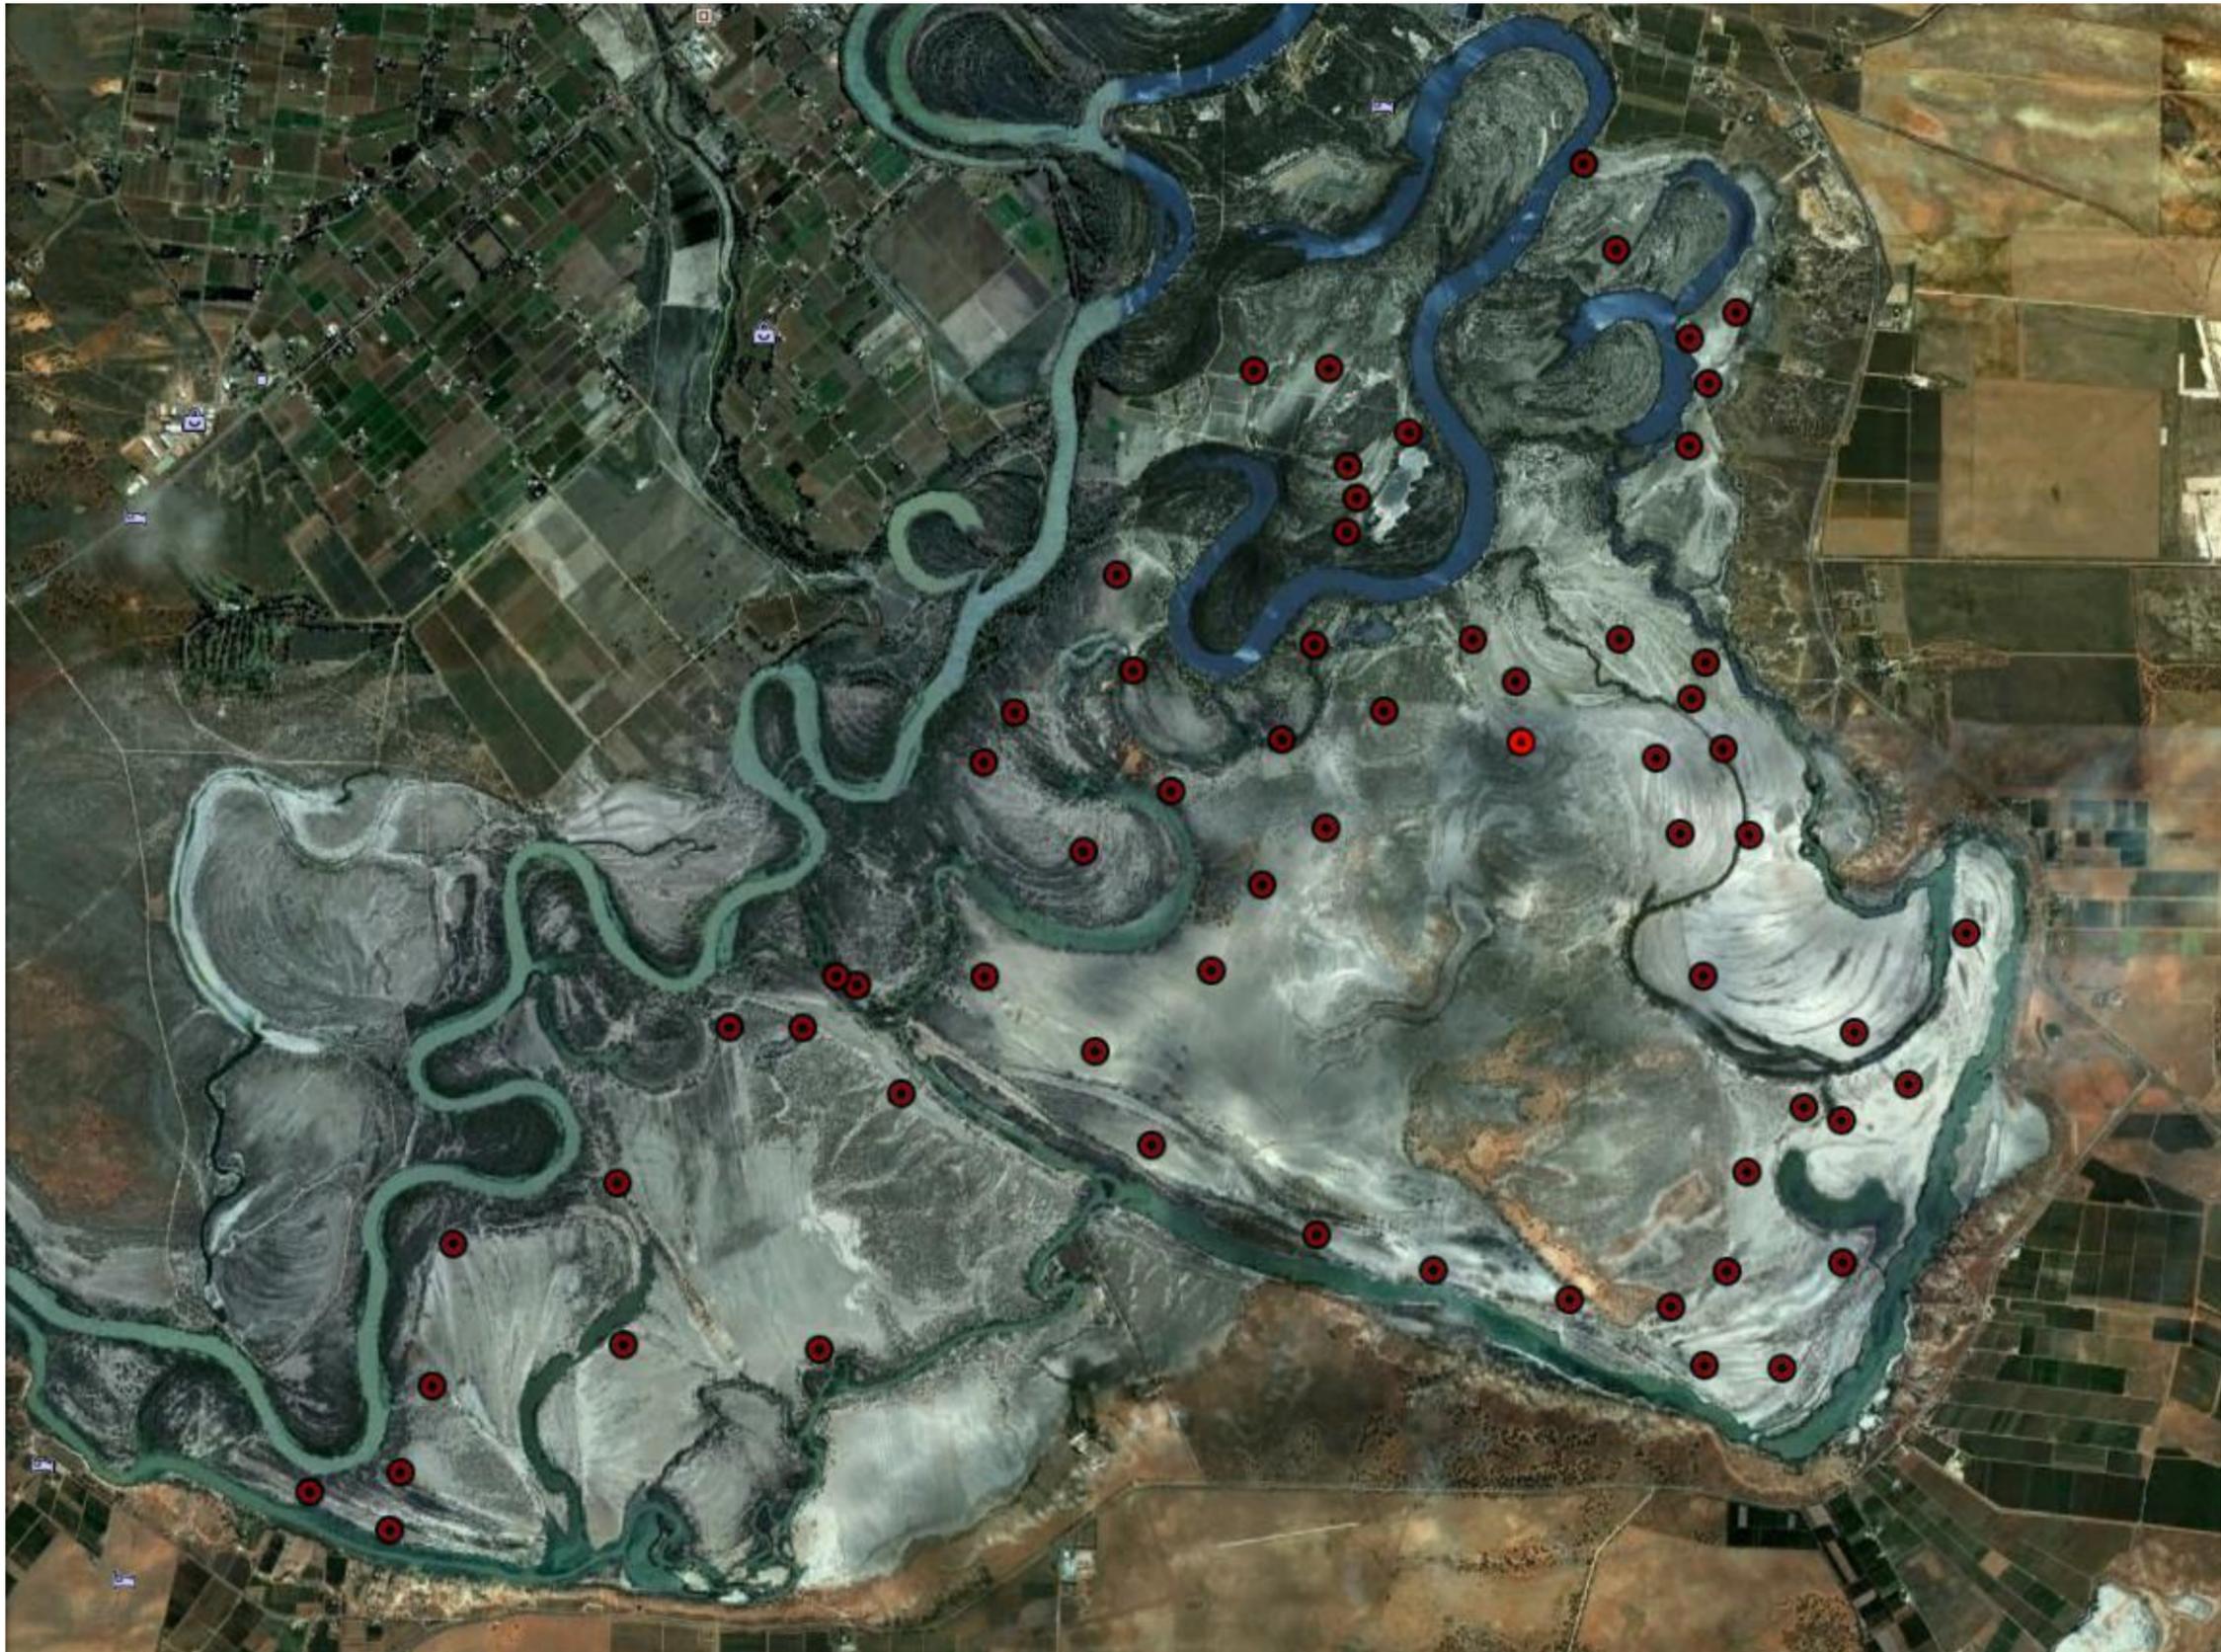
Figure 4 Aerial photograph of the Pike floodplain in February 2010. Red dots indicate floodplain vegetation monitoring sites.

The Pike floodplain is located between the townships of Remark and Berri in South Australia (Figure 4). Water enters the Pike system through two inlet creeks immediately above Lock 5, traversing Mundic Creek then flowing through to the Upper Pike which then diverges to the River Murray and the Lower Pike (Ecological Associates, 2008). A series of creeks and billabongs are fed by these major creeks, and at high river levels water also spreads into low-lying woodlands and wetlands.

Sites were established in open areas across the Pike (Figure 4) and Chowilla floodplains (Figure 5) so that they:

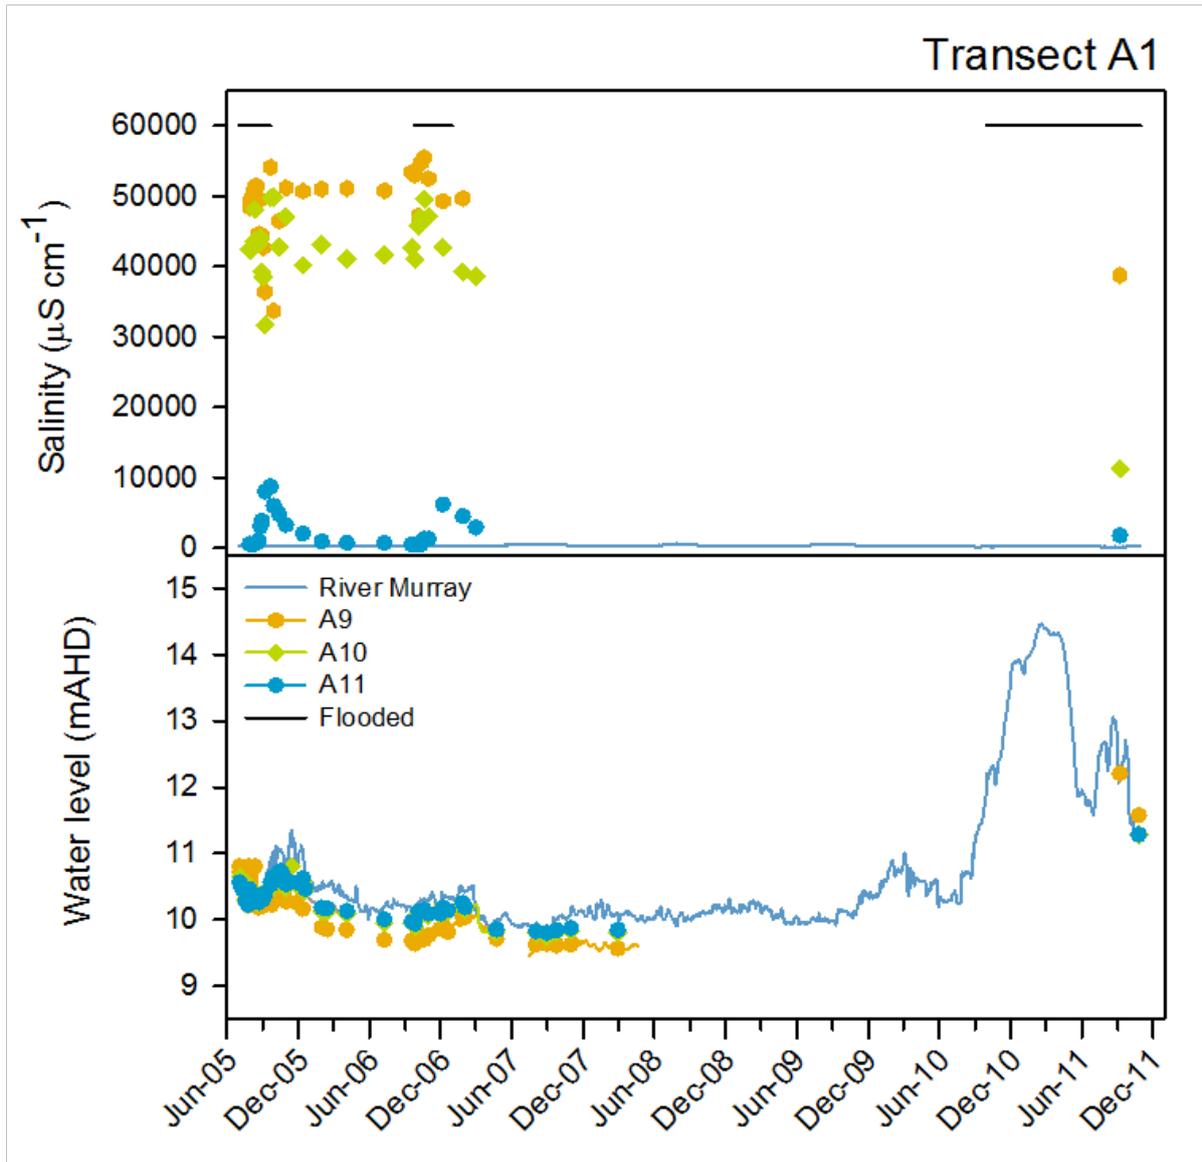
Figure 6 Transect A1 groundwater salinity ($\mu\text{S cm}^{-1}$) and water level (m AHD) measured in each piezometer between June 2005 and December 2011. River Murray water levels and wetland flooding are shown for reference.

freshening was observed in the middle of Transect A1 at piezometer A10, where groundwater salinities fell from 38,600 $\mu\text{S cm}^{-1}$ in 2007 to 11,260 $\mu\text{S cm}^{-1}$ in 2011 (Figure 6). Groundwater freshening occurred at A10 even though the piezometer was not flooded in 2010/11, which indicates that there was lateral movement of water from the wetland into the floodplain aquifer at this site.

River levels rose by over 2 m above normal pool level to 14.46 m AHD at the gauging station downstream of Lock 4 (Figure 6). Prior to the 2010/11 flood, groundwater gradients were away from the River Murray along Transects A1, A2 and A3. Groundwater levels were 0.2 to 0.3 m below river level nearest the river, increasing to 0.3 to 0.7 m below river level at the distal edges of the transects. The groundwater level at the control site (A1) was also 0.3 m below river level prior to the flood. Groundwater hydraulic gradients were reversed once River Murray water levels fell in October / November 2011. During this period, groundwater levels were up to 0.4 m above river level.

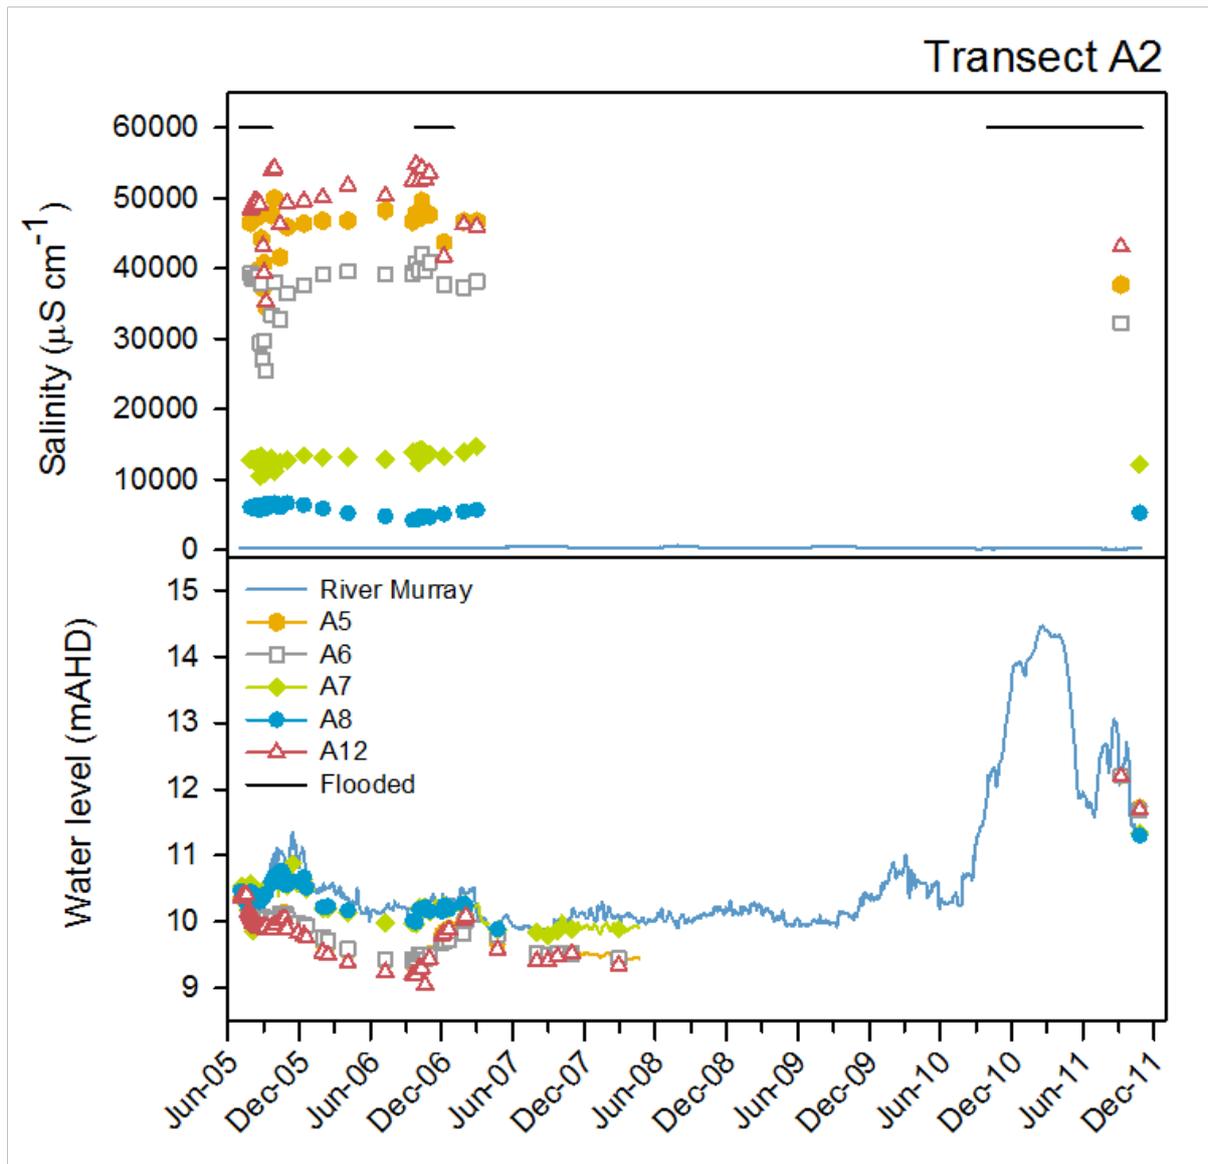
Figure 7 Transect A2 groundwater salinity ($\mu\text{S cm}^{-1}$) and water level (m AHD) measured in each piezometer between June 2005 and December 2011. River Murray water levels and wetland flooding are shown for reference.

Groundwater salinities along Transect A2 were relatively unchanged between 2007 and 2011 in four of the five piezometers, despite three of these piezometers being flooded in 2010/11 (Figure 7). This indicates that vertical recharge through the soil profile, or leakage down the outside of the piezometer casings did not affect the measured groundwater salinity values. A small decrease in groundwater salinity was observed in piezometer A5 that was not flooded, but is located near a small depression and creek that were flooded, which suggests that there was lateral movement of water from this water body into the floodplain aquifer.

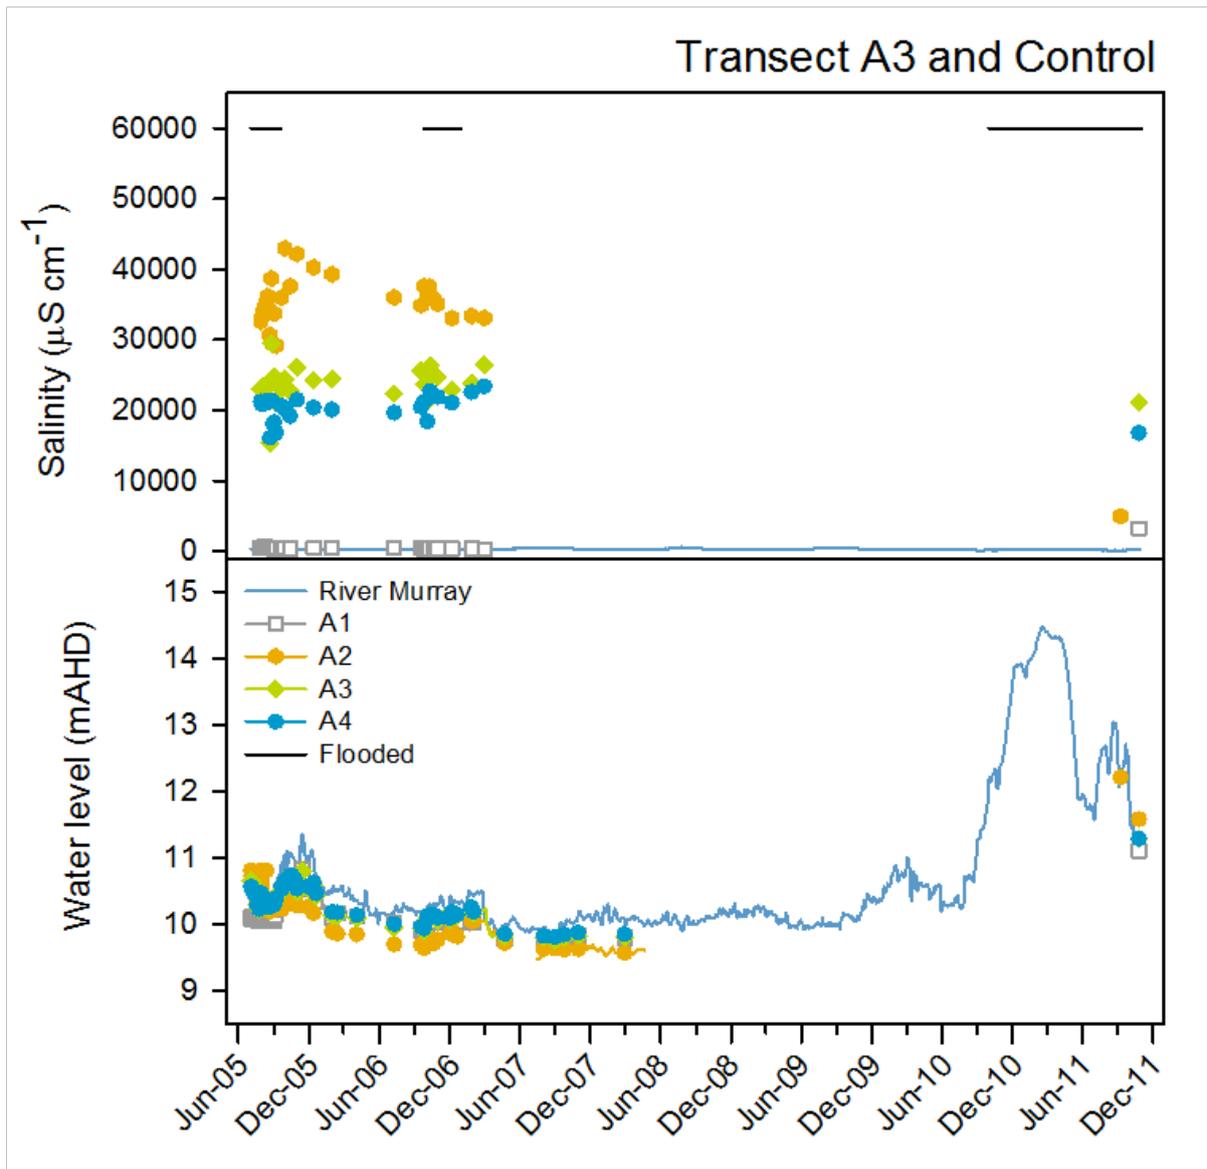
Figure 8 Transect A3 groundwater salinity ($\mu\text{S cm}^{-1}$) and water level (m AHD) measured in each piezometer between June 2005 and December 2011. River Murray water levels and wetland flooding are shown for reference.

Small decreases in groundwater salinity were observed in the three piezometers along Transect A3 after being inundated in the 2010/11 flood. The greatest decrease in groundwater salinity occurred in piezometer A2 on the northern bank of the wetland, falling from 33,100 $\mu\text{S cm}^{-1}$ in 2007 to 5010 $\mu\text{S cm}^{-1}$ in 2011 (Figure 8). Piezometer A2 was flooded and is located on the edge of the wetland. This means that the observed groundwater freshening was most probably caused by a combination of lateral bank recharge or vertical infiltration of water through the soil profile. It may also have been caused by leakage down the outside of the piezometer casing, however this is unlikely as the soil chloride values at A2 also decreased.

There was an increase in groundwater salinity at the Site A control piezometer (A1), from 340 to 3240 $\mu\text{S cm}^{-1}$ between 2007 and 2011 (Figure 8). This increase in groundwater salinity may be caused by mixing of salt from the soil profile with the groundwater due to vertical infiltration when piezometer A1 was flooded in 2010/11.

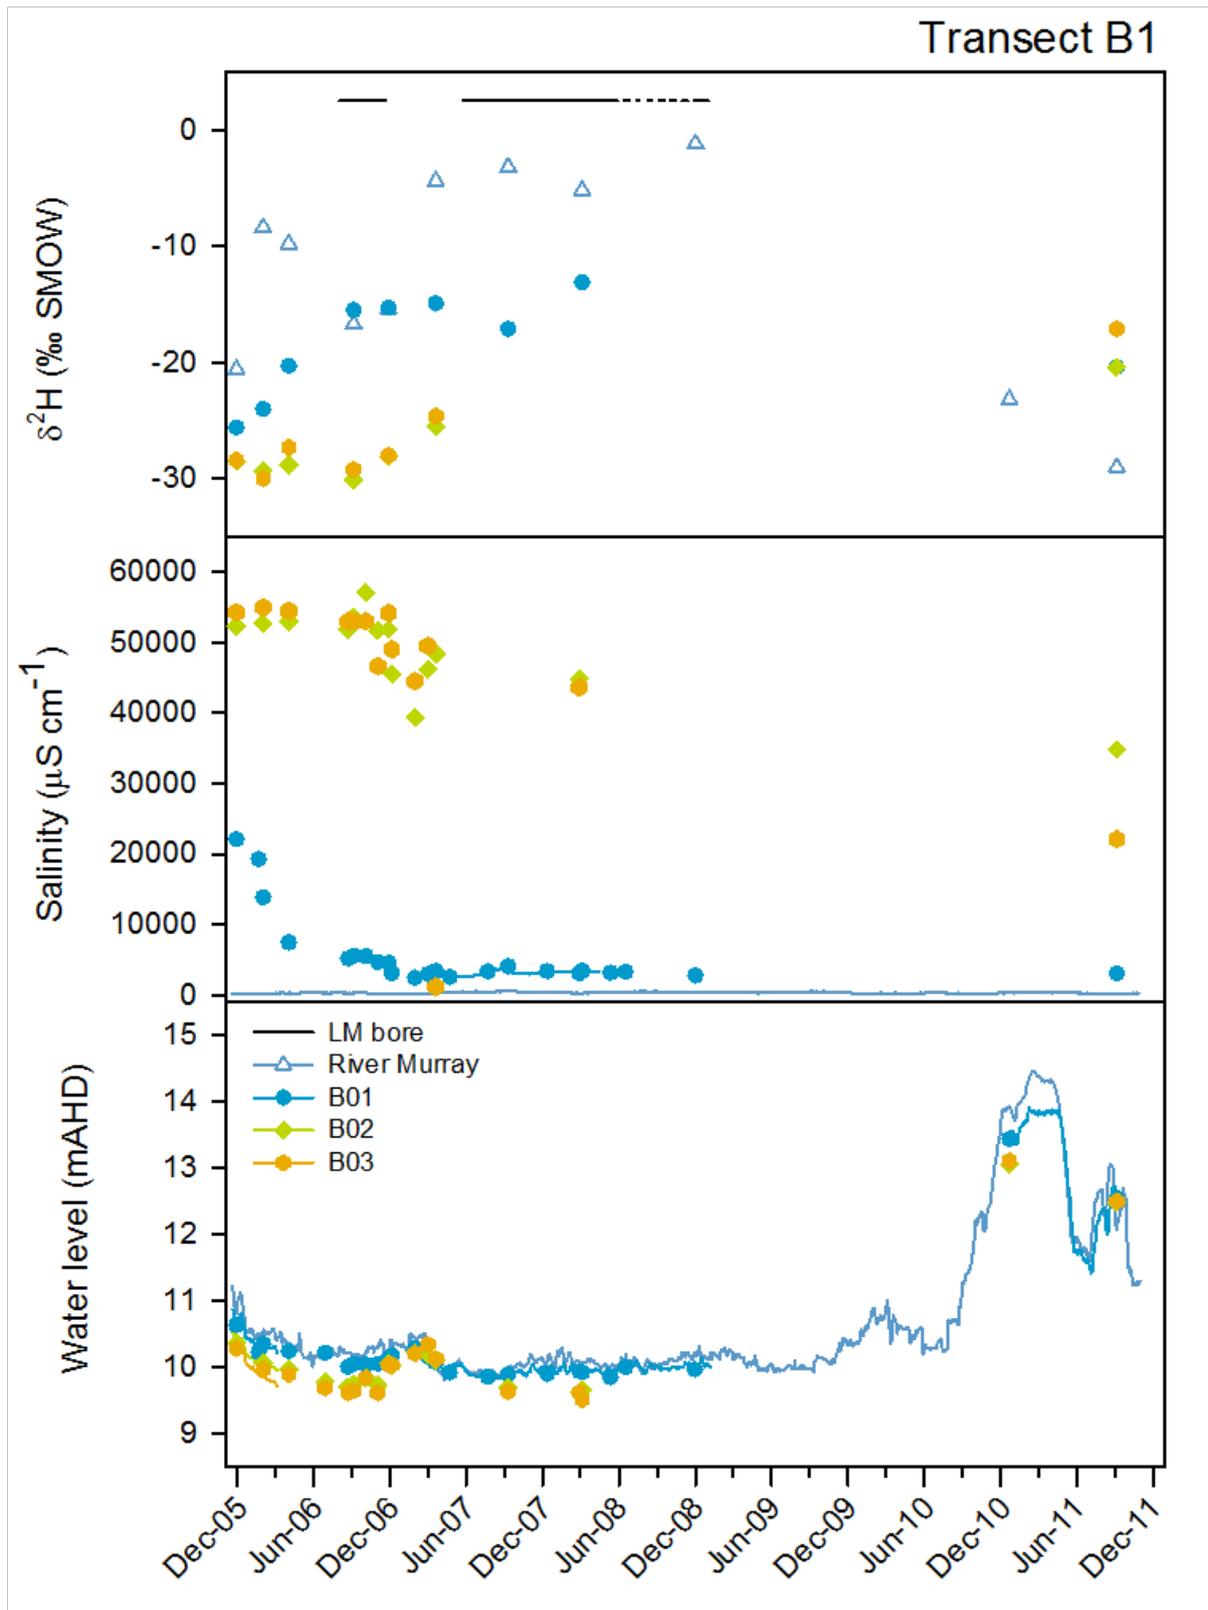
Figure 9 Transect B1 groundwater $\delta^2\text{H}$ (‰ vSMOW), salinity ($\mu\text{S cm}^{-1}$) and water level (m AHD) measured between June 2005 and December 2011. River Murray water levels and SIS operation are shown for reference.

Modest decreases in groundwater salinity were observed along Transect B1 after the flood, falling from 44,900 to 34,800 $\mu\text{S cm}^{-1}$ in the middle of the riparian zone (B02), and from 43,600 to 22,100 $\mu\text{S cm}^{-1}$ at the distal edge of the riparian zone (B03) between 2008 and 2011 (Figure 9). Piezometer B02 was not flooded, which suggests that the decrease in groundwater salinity was caused by lateral recharge from the nearby flood runner creek. Piezometer B03 was inundated and is also located near this flood runner creek, which means that the observed reduction in groundwater salinity could have been caused by lateral recharge from the creek, or vertical infiltration through the soil profile. It is also possible that leakage down the outside of the

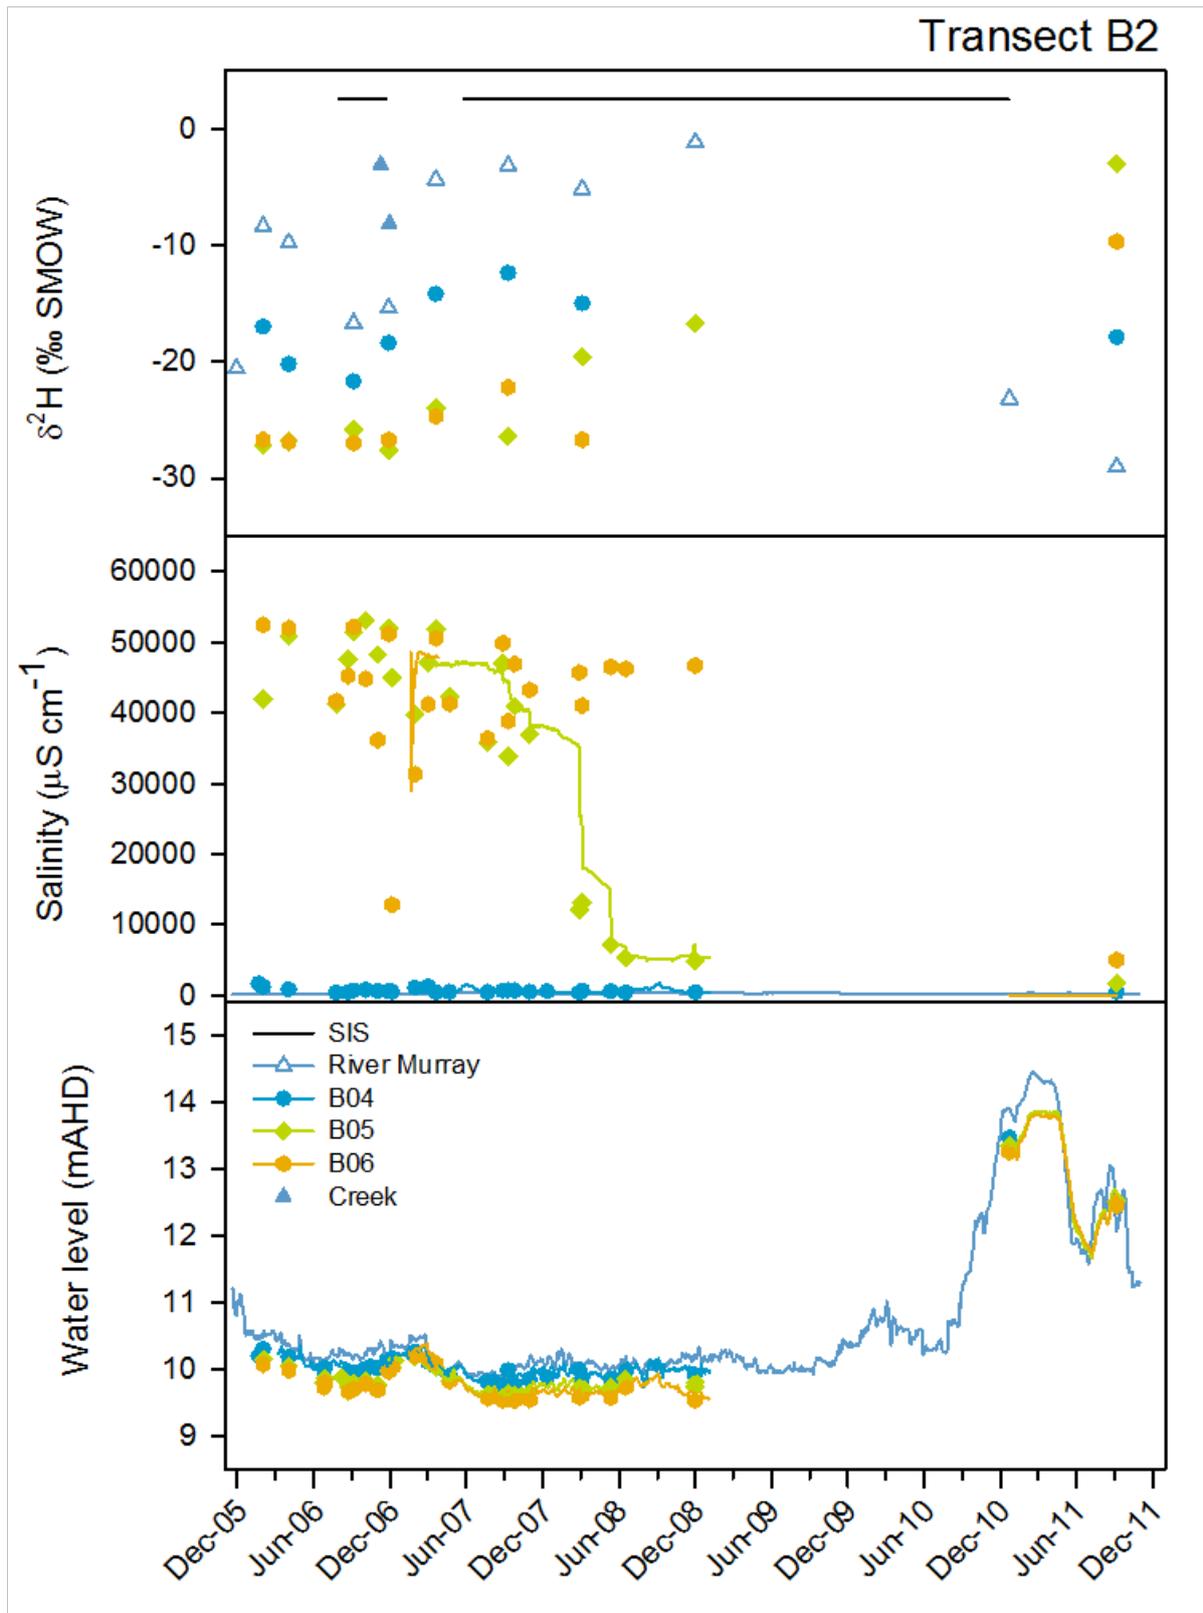
Figure 10 Transect B2 groundwater $\delta^2\text{H}$ (‰ vSMOW), salinity ($\mu\text{S cm}^{-1}$) and water level (m AHD) measured between June 2005 and December 2011. River Murray water levels and SIS operation are shown for reference.

Larger declines in groundwater salinity occurred along Transect B2 between 2008 and 2011, falling from 4900 to 1750 $\mu\text{S cm}^{-1}$ in the middle of the riparian zone (B05) and from 46,750 to 5020 $\mu\text{S cm}^{-1}$ at the distal edge of the riparian zone (B06) (Figure 10). B05 in the middle of the riparian zone was not flooded in 2010/11, which suggests that the groundwater freshening was caused by lateral recharge from the nearby creek. Groundwater freshening was observed in B06 at the distal edge of the riparian zone when it was flooded in 2006 and 2010/11. It is most likely that this was caused by vertical infiltration of floodwater through the soil profile, although it may also indicate that leakage down the outside of the piezometer casing occurred.

At Transect B2, the $\delta^2\text{H}$ value at B04 near the river ($-17.9\text{‰ } \delta^2\text{H}$) represents a mixture of resident groundwater ($-15.0\text{‰ } \delta^2\text{H}$ in 2008) and isotopically depleted floodwater (Figure 10), indicating that bank recharge occurred during the flood. The $\delta^2\text{H}$ values and groundwater freshening observed in the middle ($-3.0\text{‰ } \delta^2\text{H}$) and distal ($-9.7\text{‰ } \delta^2\text{H}$) parts of the riparian zone at Transect B2 indicate mixing of the resident groundwater ($-16.7\text{‰ } \delta^2\text{H}$ at B05 and $-26.7\text{‰ } \delta^2\text{H}$ at B06 in 2008) with isotopically enriched water. Evaporated floodwaters recharged from the nearby creek during artificial watering in 2006 (-8.2 to $-3.1\text{‰ } \delta^2\text{H}$) are a likely source. The isotopically enriched groundwater at the distal edge of the riparian zone is not consistent with leakage down the outside of the piezometer casing during the flood.

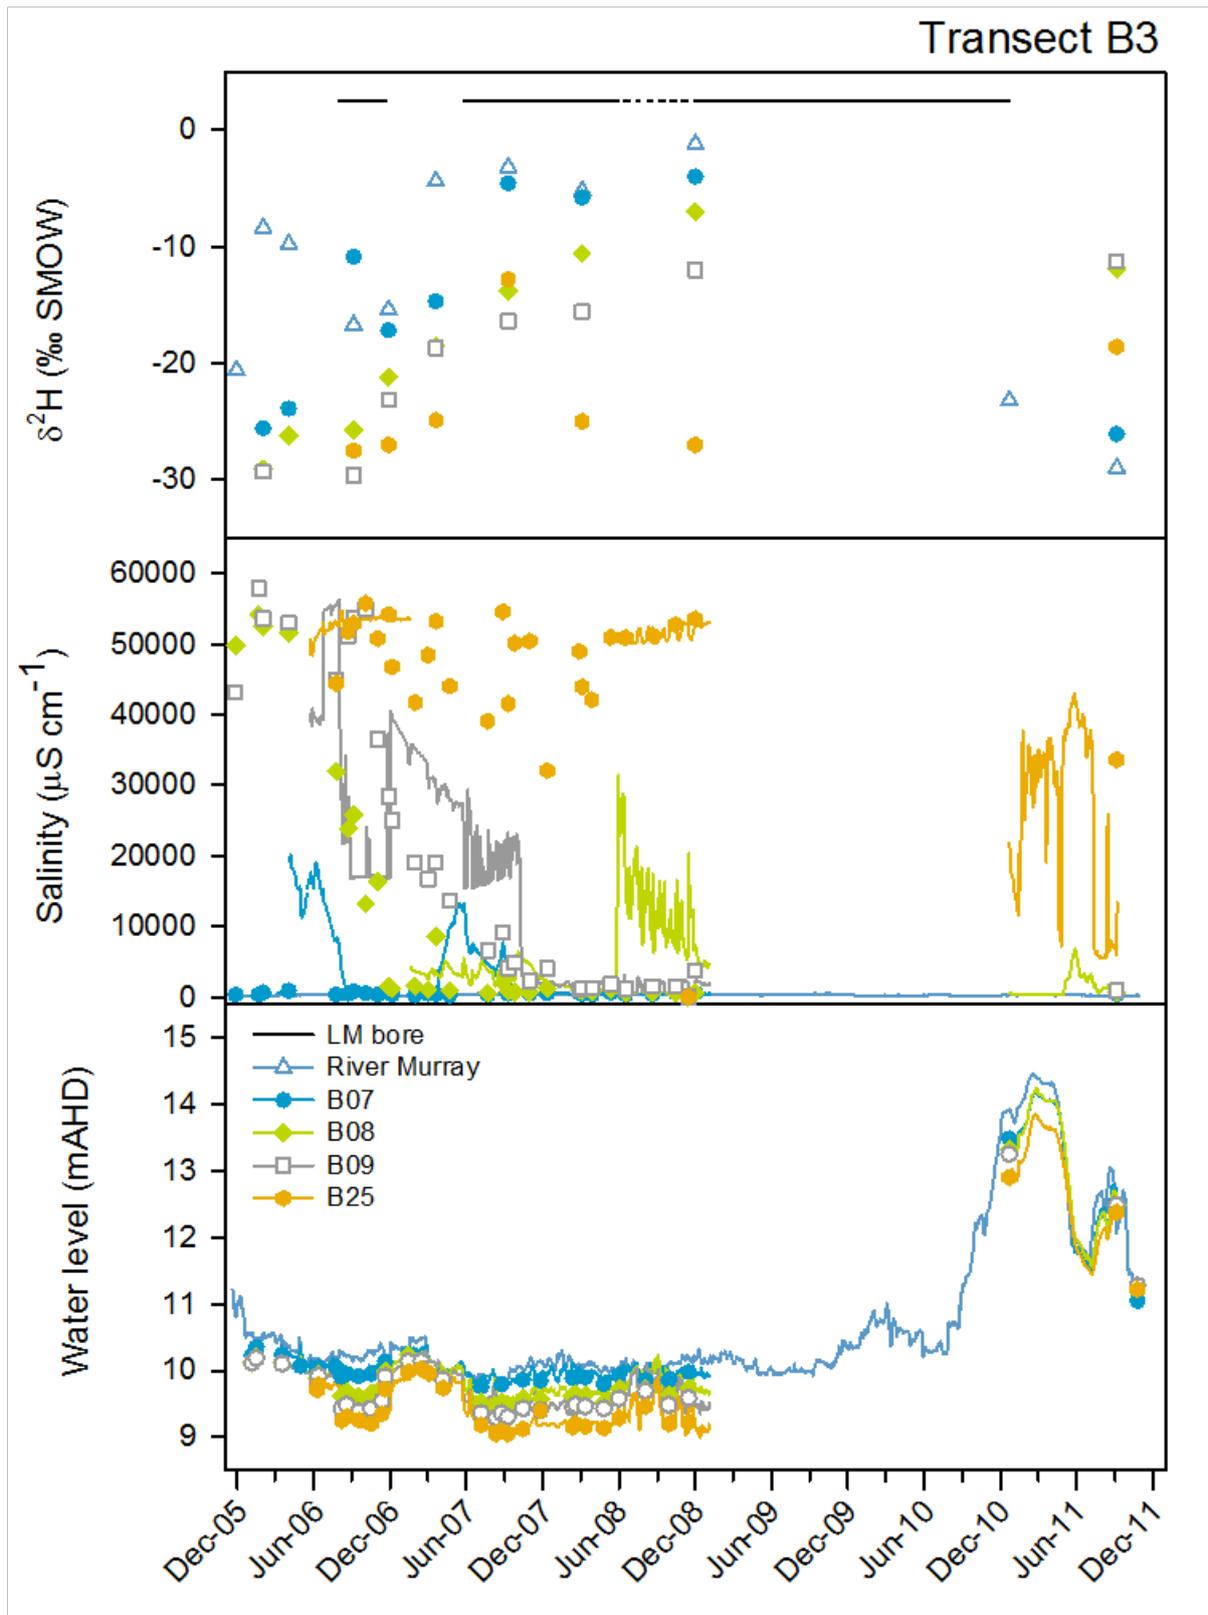
Figure 11 Transect B3 groundwater $\delta^2\text{H}$ (‰ vSMOW), salinity ($\mu\text{S cm}^{-1}$) and water level (m AHD) measured between June 2005 and December 2011. River Murray water levels and LM bore operation are shown for reference.

Groundwater freshening along Transect B3 extended to the most distal piezometer, with groundwater salinity decreasing from 52,650 to 33,600 $\mu\text{S cm}^{-1}$ at B25 (Figure 11). The hydraulic gradient created by the LM production bore maintained the low groundwater salinity across the riparian zone at Transect B3. It appears that the increased hydraulic gradient created by the flood displaced the fresh groundwater beyond the LM production bore to reduce groundwater salinities at B25. Alternatively, B25 was inundated during the 2010/11 flood, and therefore vertical infiltration of floodwater through the soil profile or possibly leakage down the outside of the piezometer casing may have reduced groundwater salinities.

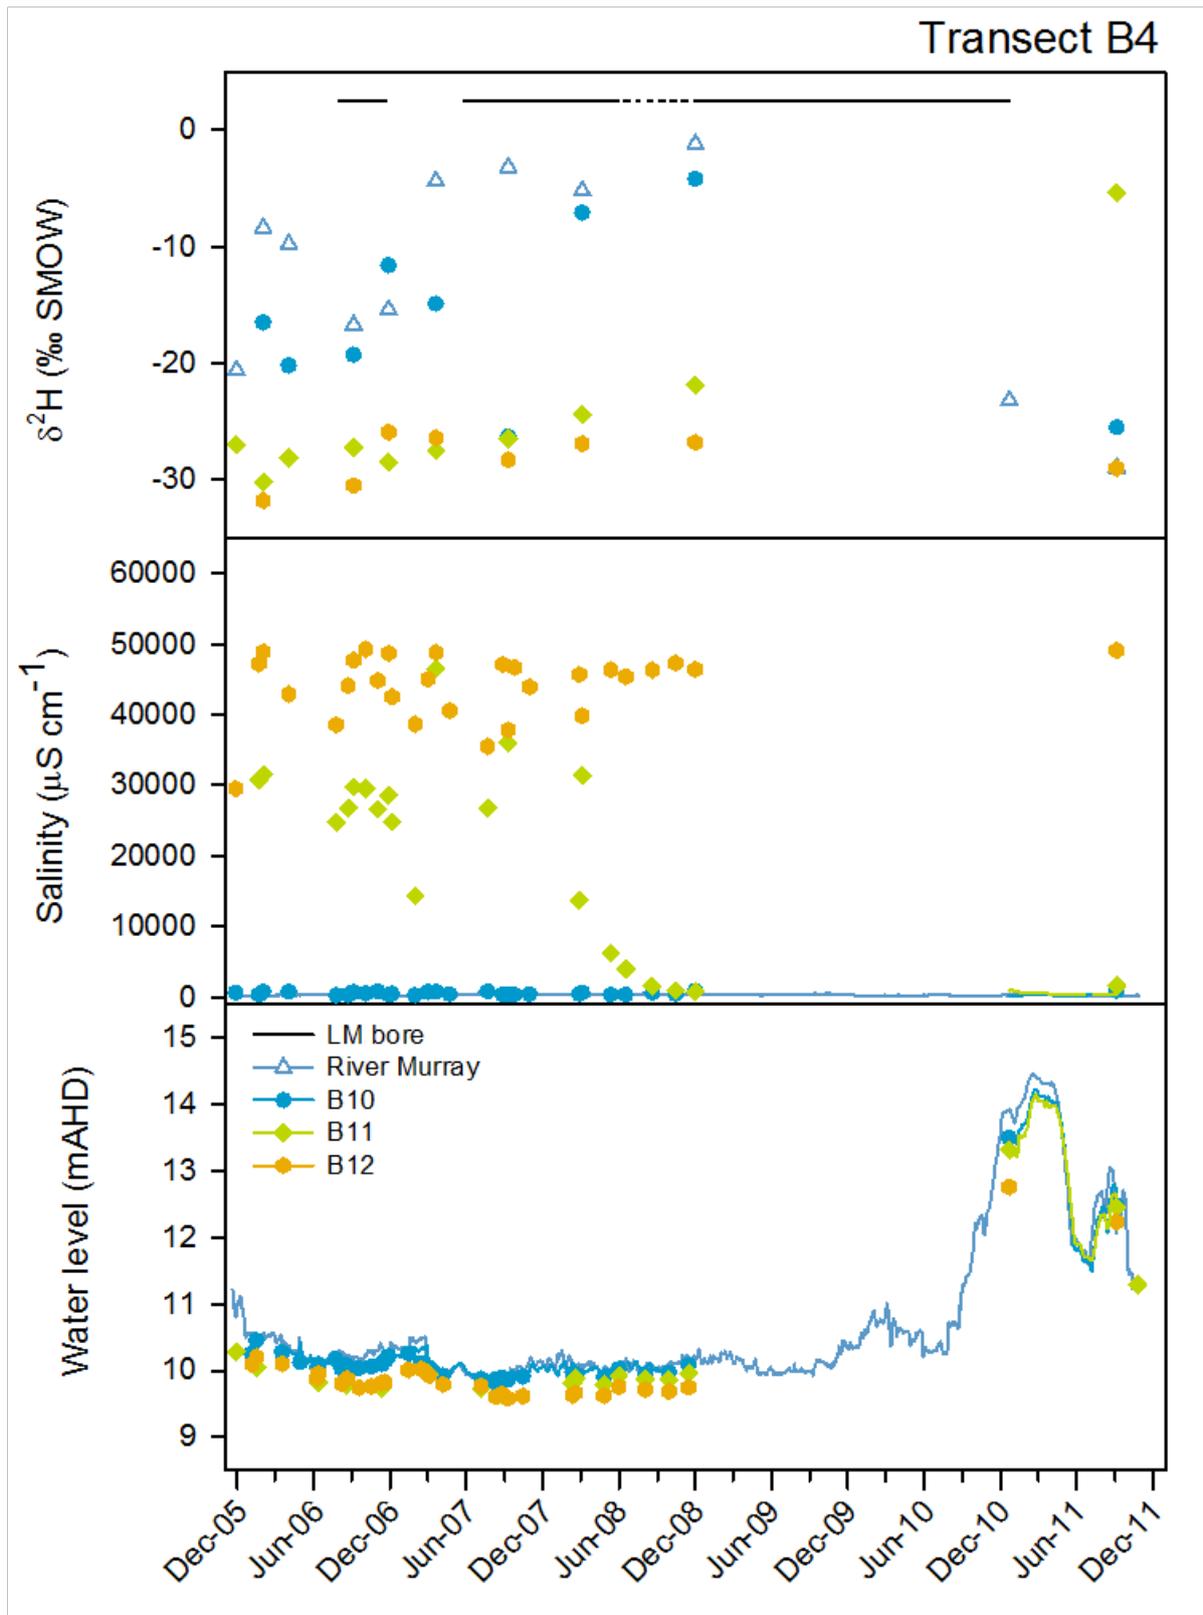
Figure 12 Transect B4 groundwater $\delta^2\text{H}$ (‰ vSMOW), salinity ($\mu\text{S cm}^{-1}$) and water level (mAHD) measured between June 2005 and December 2011. River Murray water levels and SIS operation are shown for reference.

Transect B4 was not inundated during the 2010/11 flood. However, groundwater salinity in the middle of the riparian zone fell from 31,430 to 1610 $\mu\text{S cm}^{-1}$ between 2008 and 2011 (Figure 12). It is likely that this was caused by the lateral movement of low salinity groundwater away from the river in response to the hydraulic gradient caused by the flood. In contrast, groundwater at the distal edge of Transect B4 (B12) remained saline, being 46,400 $\mu\text{S cm}^{-1}$ in 2008 and 49,100 $\mu\text{S cm}^{-1}$ in 2011.

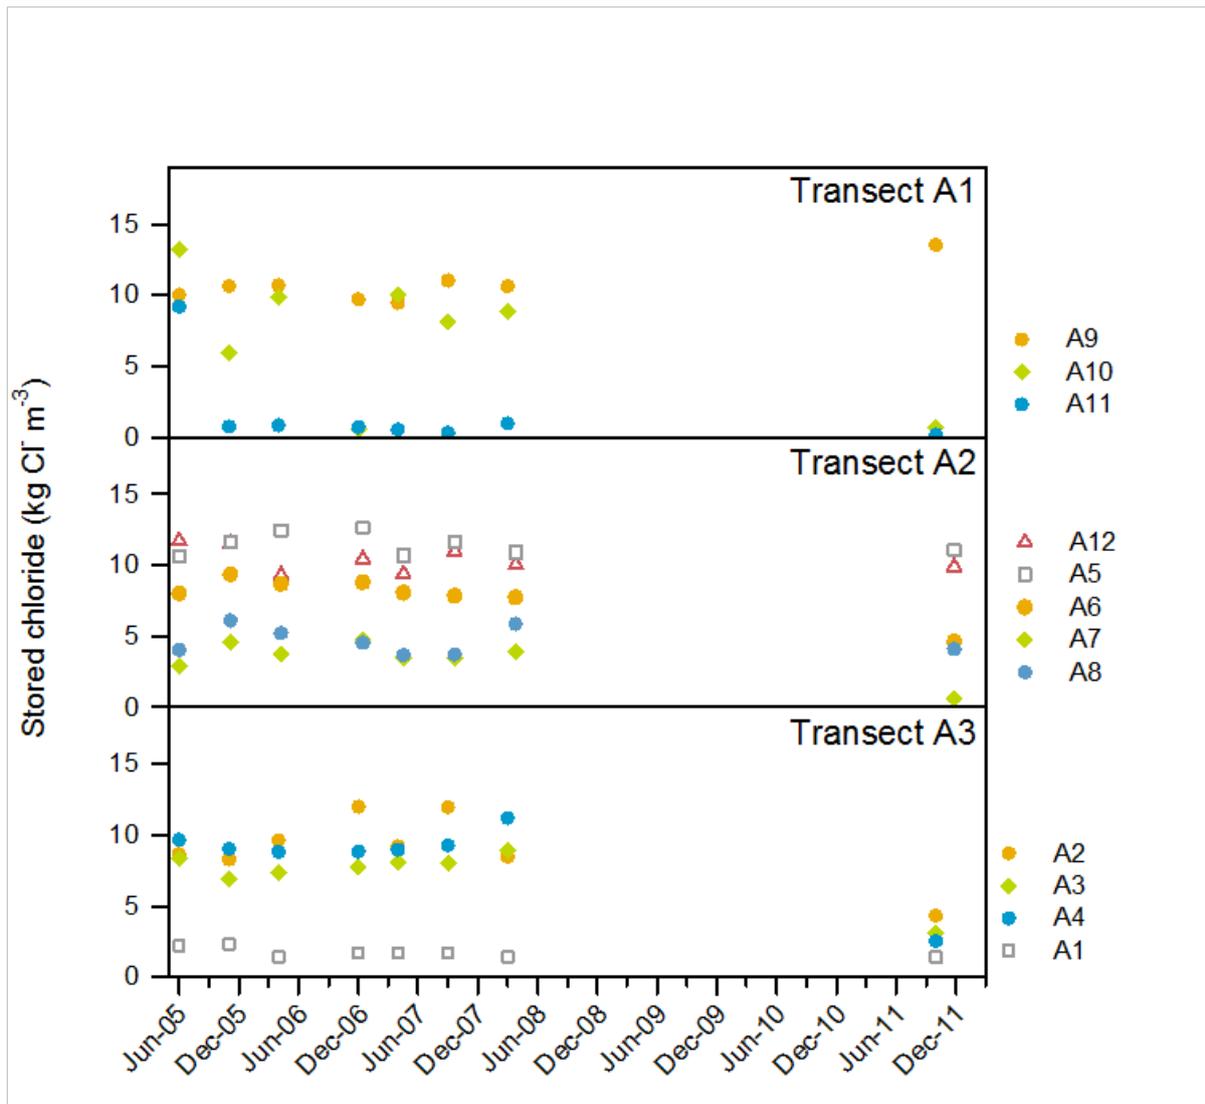
Figure 13 Site A soil chloride values (kg Cl⁻ m⁻³) for soil profiles sampled between June 2005 and December 2011.

At Transect A1, there was a reduction in stored soil chloride at A11 following inundation from $1.0 \text{ kg Cl}^- \text{ m}^{-3}$ in 2008 to $0.2 \text{ kg Cl}^- \text{ m}^{-3}$ in 2011 (Figure 13). The low salinity and consistent soil chloride profile suggests good mixing of soil water, possibly from vertical infiltration from the surface and / or vertical movement of low salinity groundwater upwards as the water table rose during the flood (Figure 14). Despite not being flooded, stored soil chloride at A10 decreased from $9 \text{ kg Cl}^- \text{ m}^{-3}$ in 2008 to $0.7 \text{ kg Cl}^- \text{ m}^{-3}$ in 2011 (Figure 13). The soil profile shows a reduction in soil chloride values between $\sim 0.5 \text{ m}$ depth and the water table, which suggests that there was lateral movement of low salinity water from the wetland through the bank in response to the 2 m rise in river levels during the flood (Figure 15). The increase in stored chloride observed at A9 from $10.6 \text{ kg Cl}^- \text{ m}^{-3}$ in 2008 to $13.5 \text{ kg Cl}^- \text{ m}^{-3}$ in 2011 (Figure 13) appears to be caused by the movement of high salinity groundwater up through the soil profile during the flood.

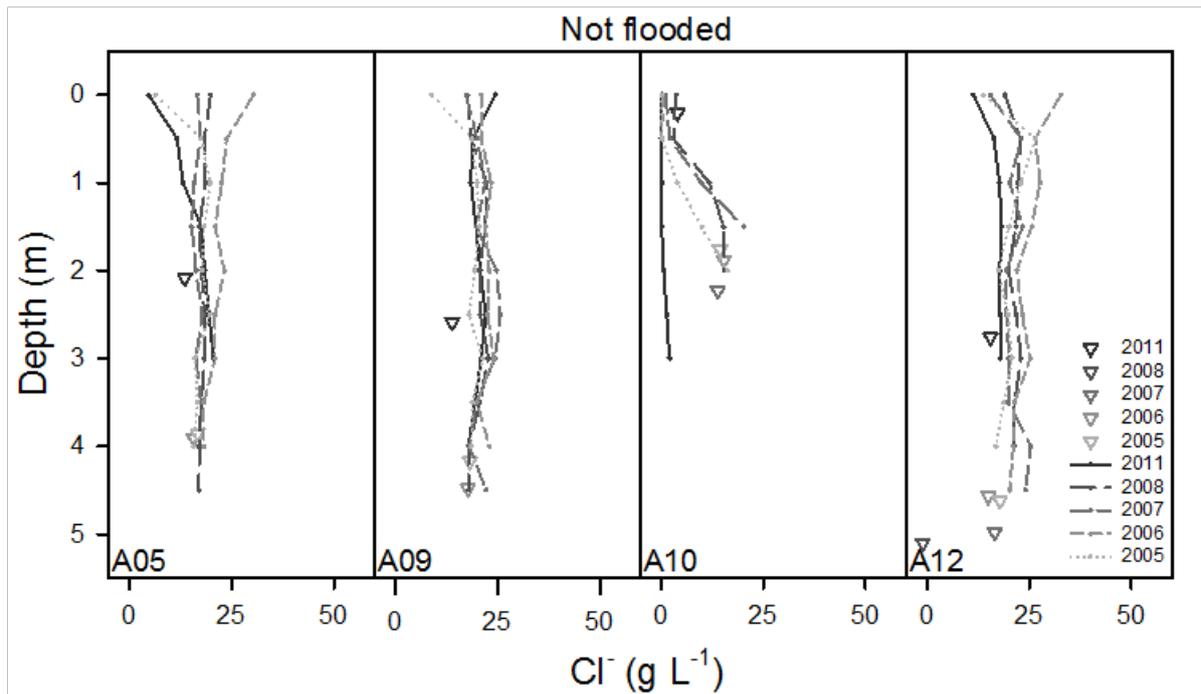
Figure 15 Not flooded Site A soil chloride profiles ($\text{g Cl}^- \text{L}^{-1}$) sampled between June 2005 and December 2011.
