FLOODPLAIN RESPONSE AND RECOVERY: COMPARISON BETWEEN NATURAL AND ARTIFICIAL FLOODS

Goyder Institute for Water Research
Technical Report Series No. 13/4

Holland KL, Turnadge CJ, Nicol JM, Gehrig SL and Strawbridge AD. (2013) *Floodplain response and recovery: comparison between natural and artificial floods*, Goyder Institute for Water Research Technical Report Series No. 13/4, Adelaide, South Australia

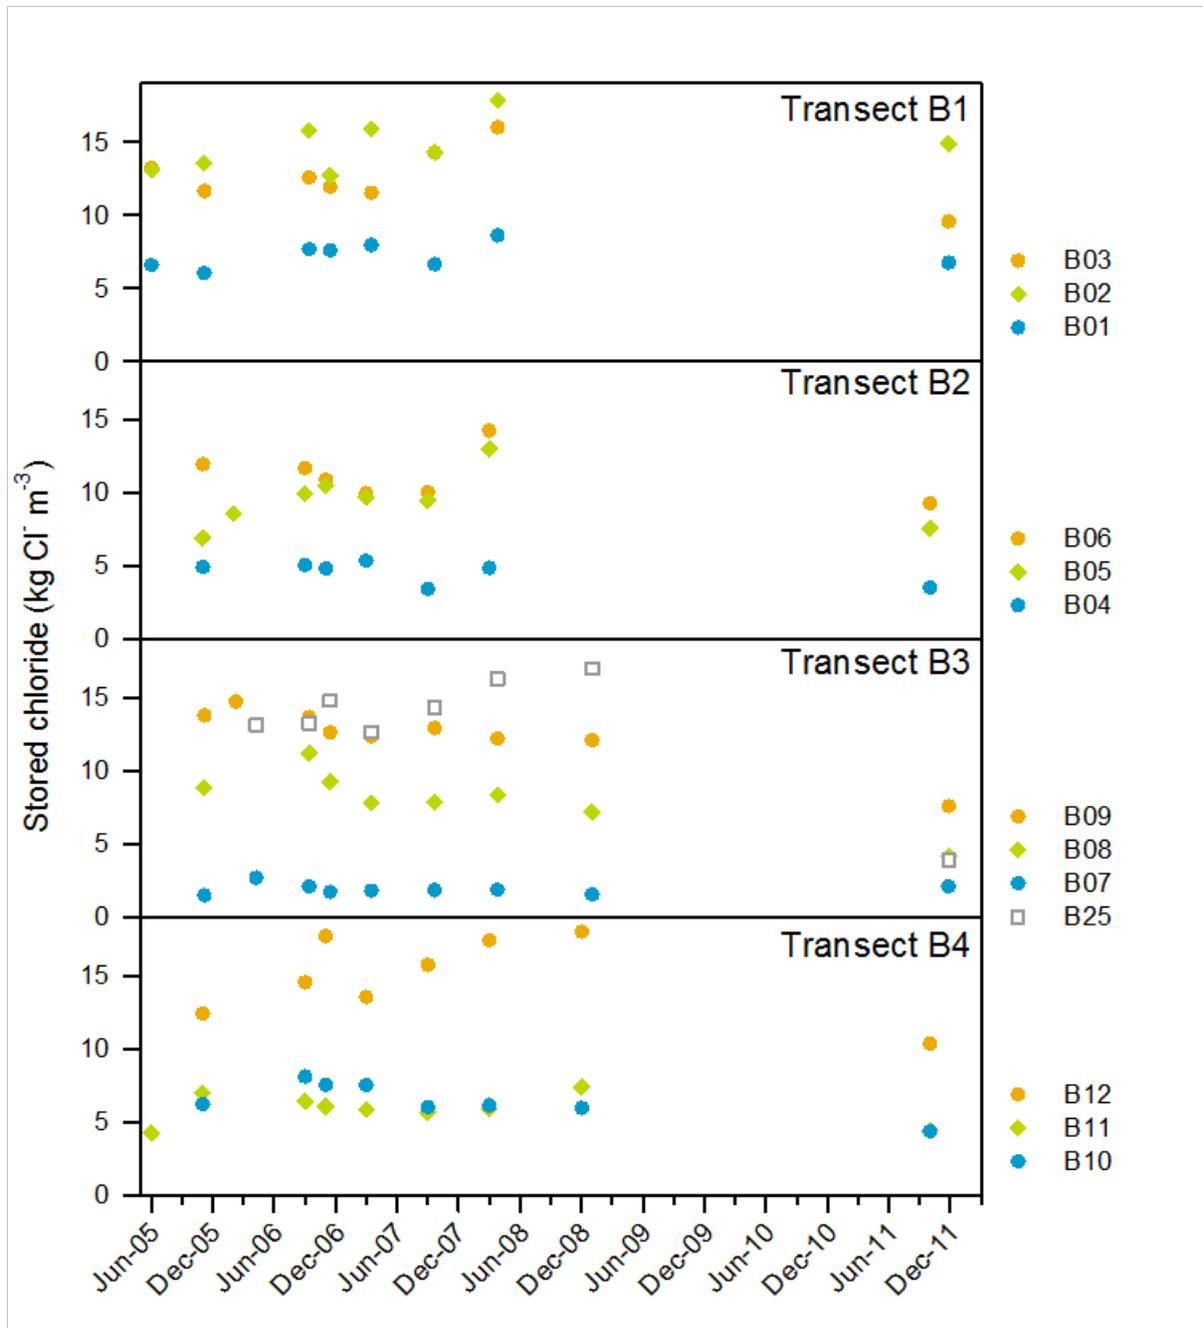
Figure 16 Site B soil chloride values (kg Cl⁻ m⁻³) for soil profiles sampled between June 2005 and December 2011.

Flooding did not inundate the sites at Transect B4. Despite this, reductions in stored chloride values were observed at all three sites (Figure 16). The soil chloride profiles show that there was leaching of salts between 0.5 m depth and 2.0 m at B10, and 3.0 m at B11 and B12 (Figure 18). This is consistent with the vertical movement of low salinity groundwater from the water table through the soil profile to within 0.5 m of the surface during the flood.

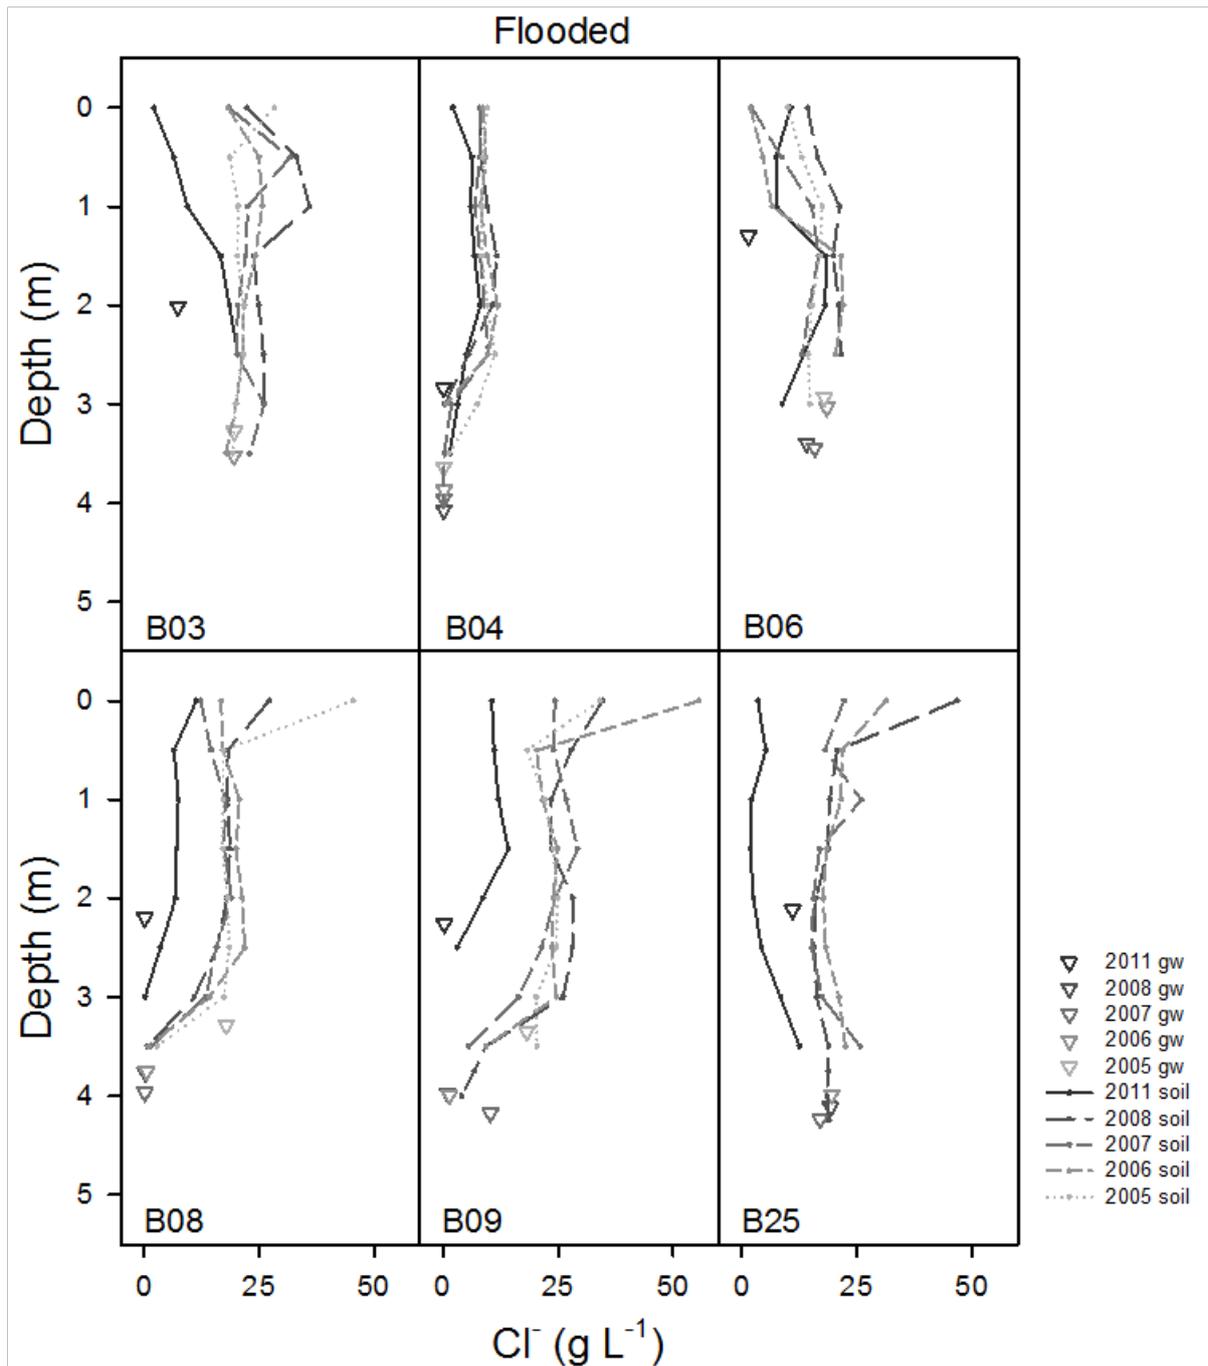
Figure 17 Flooded Site B soil chloride profiles ($\text{g Cl}^- \text{L}^{-1}$) sampled between June 2005 and December 2011.

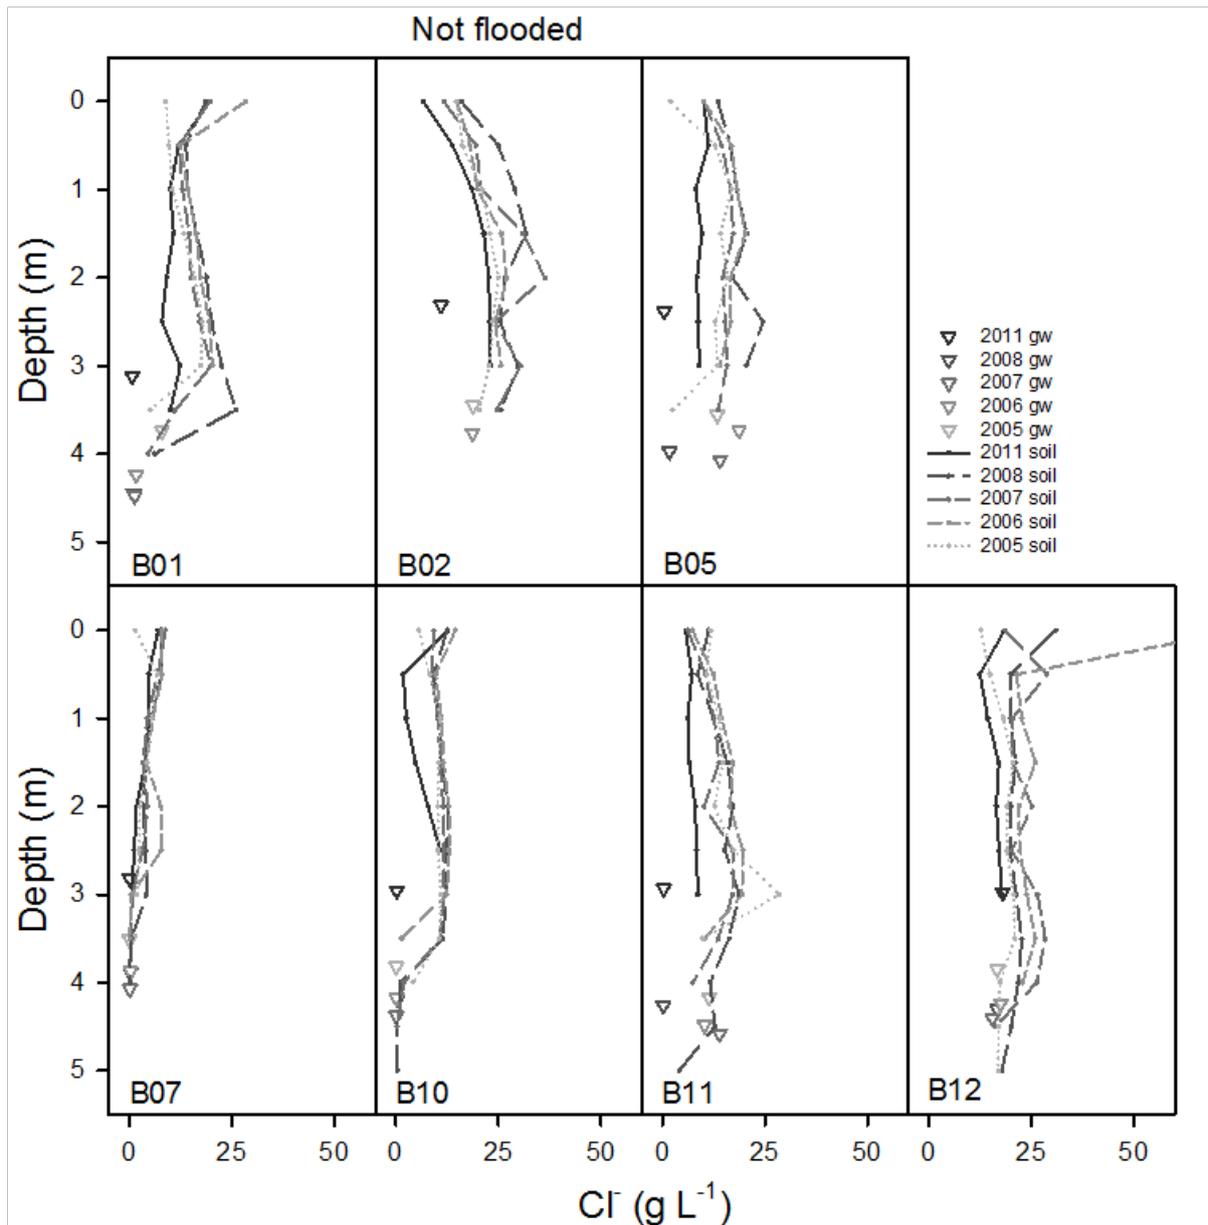
Figure 18 Not flooded Site B soil chloride profiles ($\text{g Cl}^- \text{L}^{-1}$) sampled between June 2005 and December 2011.

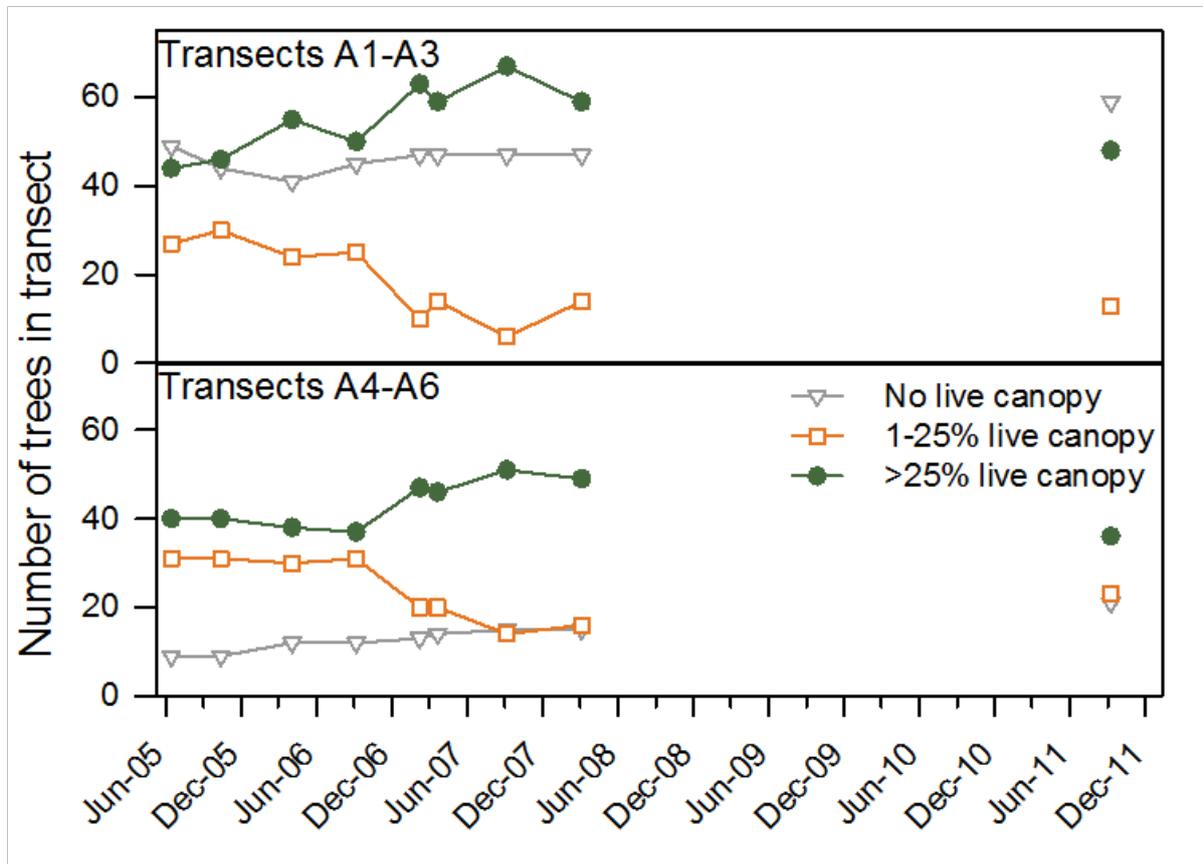
Figure 19 Site A changes in canopy condition between June 2005 and December 2011 at the treatment (A1-A3) and control (A4-A6) transects.

September / October 2011. Elevated water tables create waterlogged conditions, which in combination with salinity are known to reduce plant growth and water use (van der Moezel *et al.* 1988; Marcar 1993; Bell 1999). Therefore, it is likely that when river levels fall, increased tree water availability will improve the canopy condition of the floodplain trees.

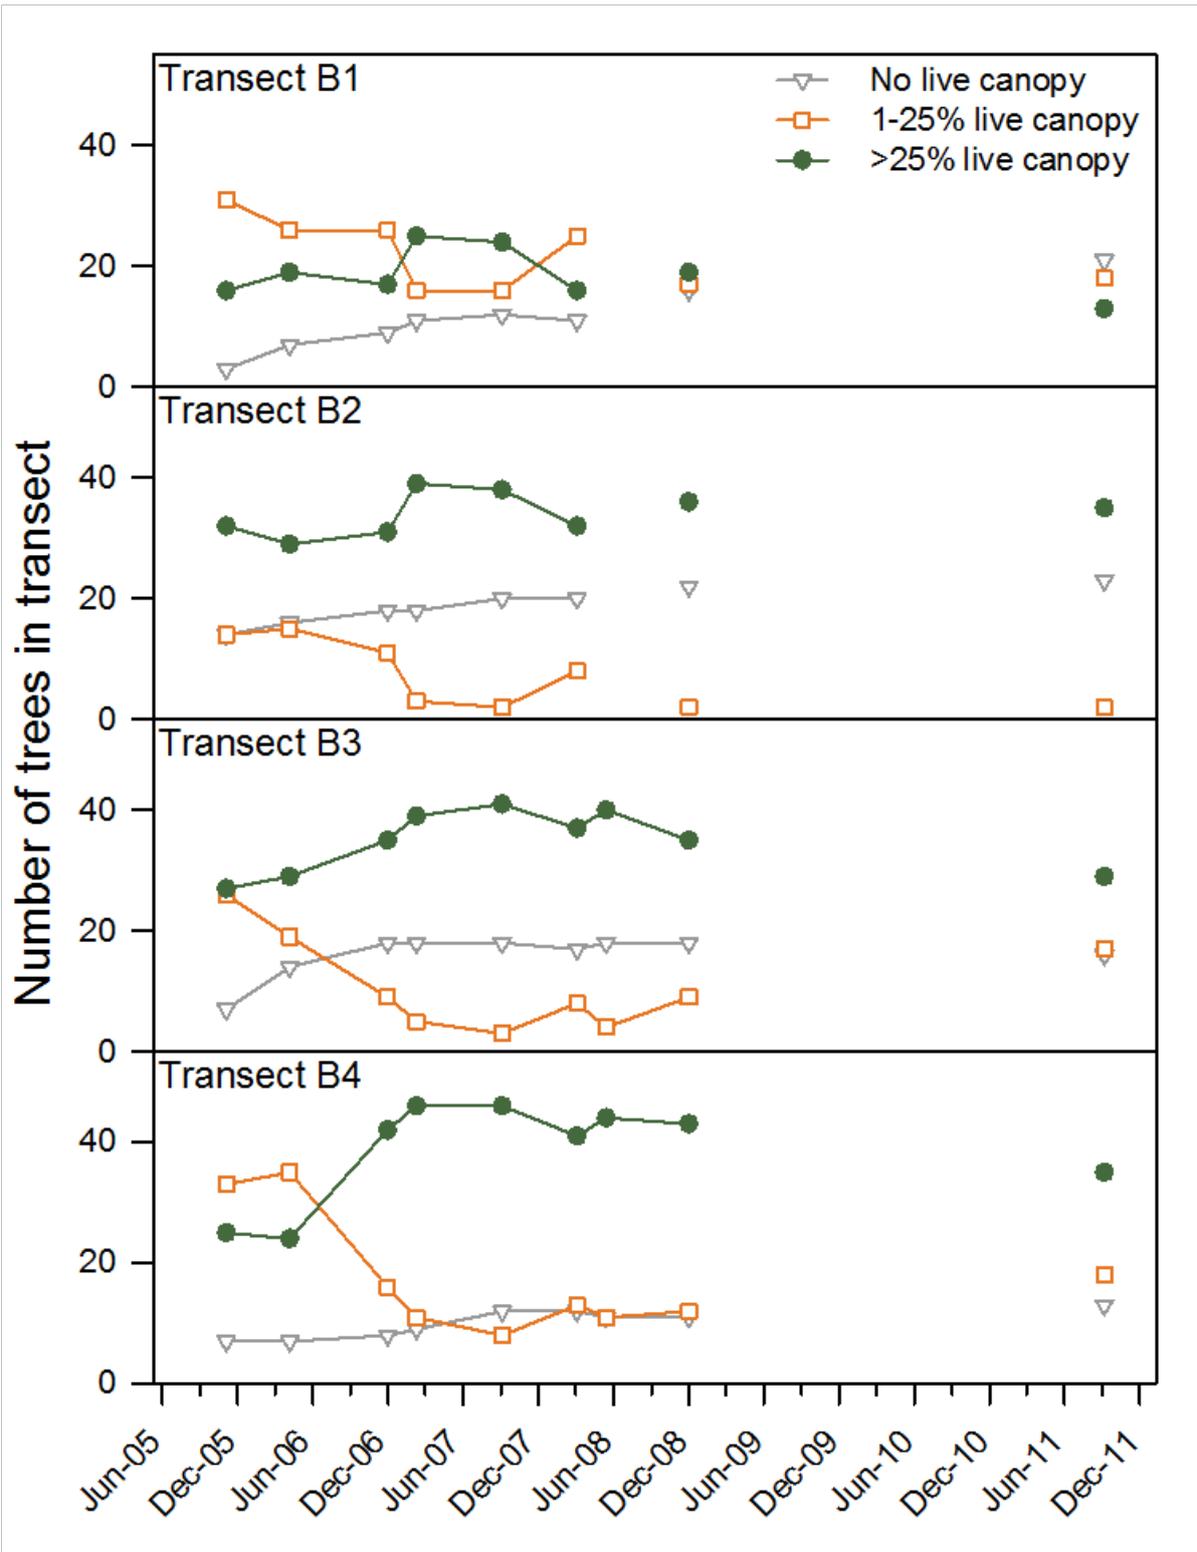
Figure 20 Site B changes in canopy condition between June 2005 and December 2011.

At the start of the Bookpurnong Experiment, tree health was generally poor, with most of the trees having less than 25% live canopy along the treatment (B1 – 68%, B2 – 45% and B3 – 55%) and control (B4, 62%) transects (Figure 20). Over the three years of the experiment, increases in the proportion of trees with >25% live canopy were observed at Transects B1 (+4%), B2 (+7%), B3 (+11%) and B4 (+27%). The increase in the number of trees with more than 25% live canopy observed at Transects B3 and B4 was caused by the transition of trees from the 1-25% live canopy class to the >25% live canopy class, indicating an improvement in tree health at these transects. There was a decrease in the number of trees with minimal to sparse (1-25%) live canopy at all four transects between December 2005 and December 2008. Increases in the proportion of trees with no live canopy over this time period were observed at Transects B1 (+25%), B2 (+13%), B3 (+17%) and B4 (+6%). Between 2008 and after the flood in 2011, there was an increase in the proportion of trees with no live canopy at Transect B1 (+9%) and B4 (+3%). Similarly, there were fewer trees with >25% live canopy at Transects B1 (–12%), B2 (–2%), B3 (–9%) and B4 (–12%). With the exception of Transect B1, there was an increase in the number of trees with moderate to maximum (>25%) live canopy at Transects B2, B3 and B4 between 2005 and 2011. At the same time, there was an increase in the number of trees with no live canopy, demonstrating the effect of the regional drought. These increases came from the intermediate canopy class, with some continuing to decline and some improving in response to increased water availability associated with artificial watering and groundwater management.

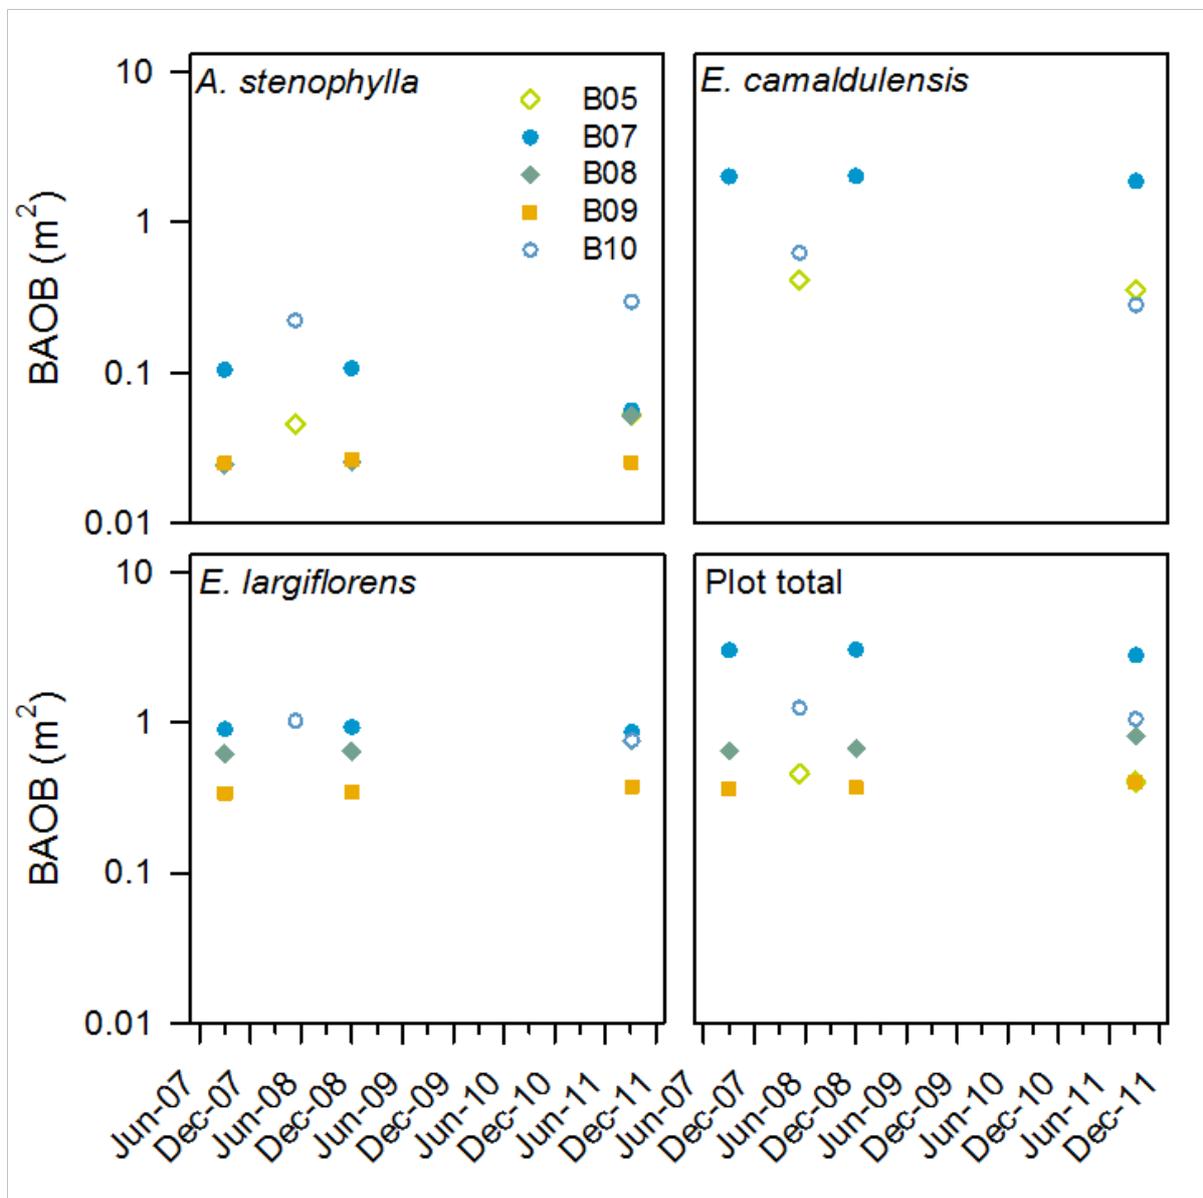
Figure 21 Site B changes in plot basal area over bark (BAOB, m²) for *A. stenophylla*, *E. camaldulensis*, *E. largiflorens* and plot total between September 2007 and September 2011. Note the semi-logarithmic plot.

Changes in DBH or BAOB were used to detect long term tree growth at Site B. Between 2008 and 2011 at B05 in the middle of Transect B2, *A. stenophylla* BAOB increased by 16% (Figure 21). Whereas, the death of two of the *E. camaldulensis* trees in this plot reduced *E. camaldulensis* BAOB by 14% over this period. Along Transect B3, BAOB increased between 2007 and 2008 at all three plots. In contrast, between 2008 and 2011, BAOB of all three species at B07 near the river decreased; with total plot BAOB falling by 7%. In the middle of the riparian zone along Transect B3 at B08, BAOB of *A. stenophylla* and *E. largiflorens* increased, with *A. stenophylla* BAOB doubling and total plot BAOB increasing by 25% between 2007 and 2011. At the distal edge of the riparian zone along Transect B3, there were small increases in *A. stenophylla* and *E. largiflorens* BAOB between 2007 and 2008. Between 2008 and 2011, there was a small decrease in *A. stenophylla* BAOB, whereas *E. largiflorens* BAOB increased by 11%, increasing total plot BAOB by 10%. Near the river along the control transect (B4), *A. stenophylla* BAOB increased by 33%, *E. camaldulensis* BAOB decreased by 55% (including two dead trees) and *E. largiflorens* BAOB decreased by 26%, resulting in a decrease in total plot BAOB of 16%. Tree growth as measured by an increase in plot BAOB occurred in the middle and distal parts of Transect B3, where groundwater freshening was greatest,

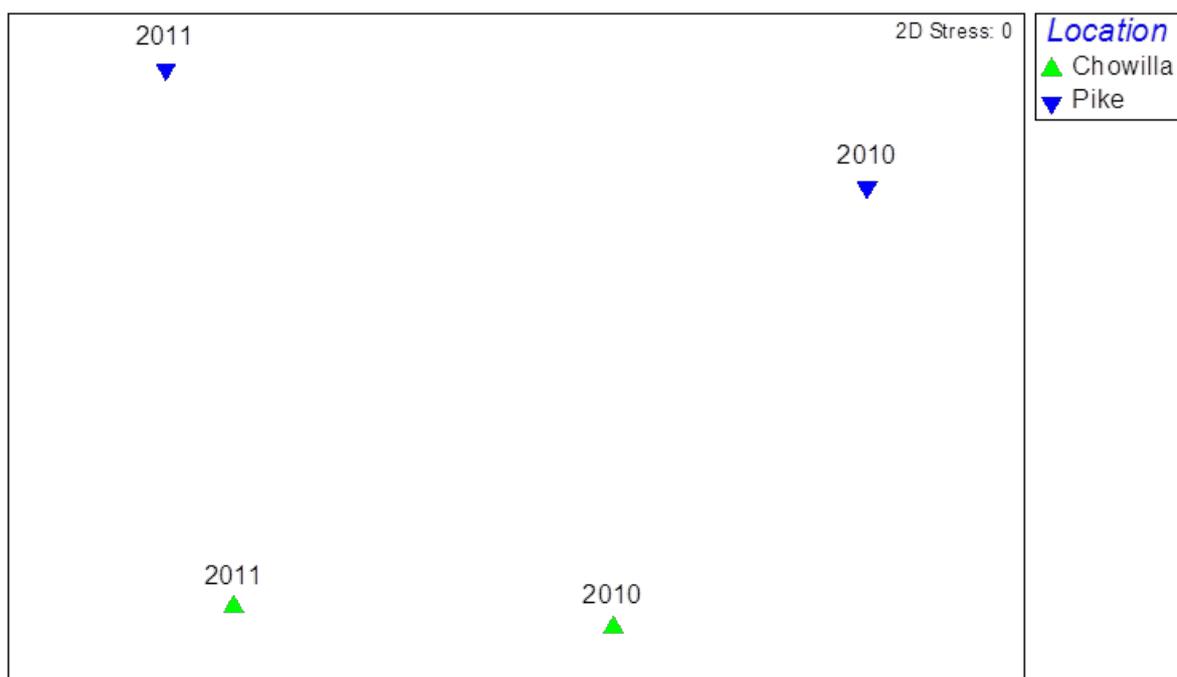
Figure 22 NMS ordination comparing understorey floristic composition between survey dates (2010 and 2011) on the Pike and Chowilla Floodplains (data were pooled for each floodplain and year for clarity).

The understorey plant community across both floodplains at each survey date were spatially variable. However, the understorey plant community across the entire floodplain (at each location) was significantly different between floodplains, between years and there was a significant interaction (Table 7). This indicates that the change in the understorey plant community through time was not consistent between the different floodplains. NMS ordination (Figure 22) shows that there was a large difference between plant communities on the Pike and Chowilla floodplains on each survey date. However, there was a greater change in floristic composition between survey dates for the Pike floodplain (Figure 22).

Appendix C). The smaller NMS ordination distance between the 2010 and 2011 surveys on the Chowilla floodplain compared to the Pike floodplain (Figure 22) represents the greater change in floristic composition observed on the Pike floodplain compared to at Chowilla due to flooding (the source of the significant interaction Table 7).
